STEAM PADDLE TUG EPPLETON HALL

Historic Structure Report
1990
DRAFT

Historic Structure Report

Tri-Coastal Marine, Inc.
200 Burrows Street
San Francisco, CA. 94134

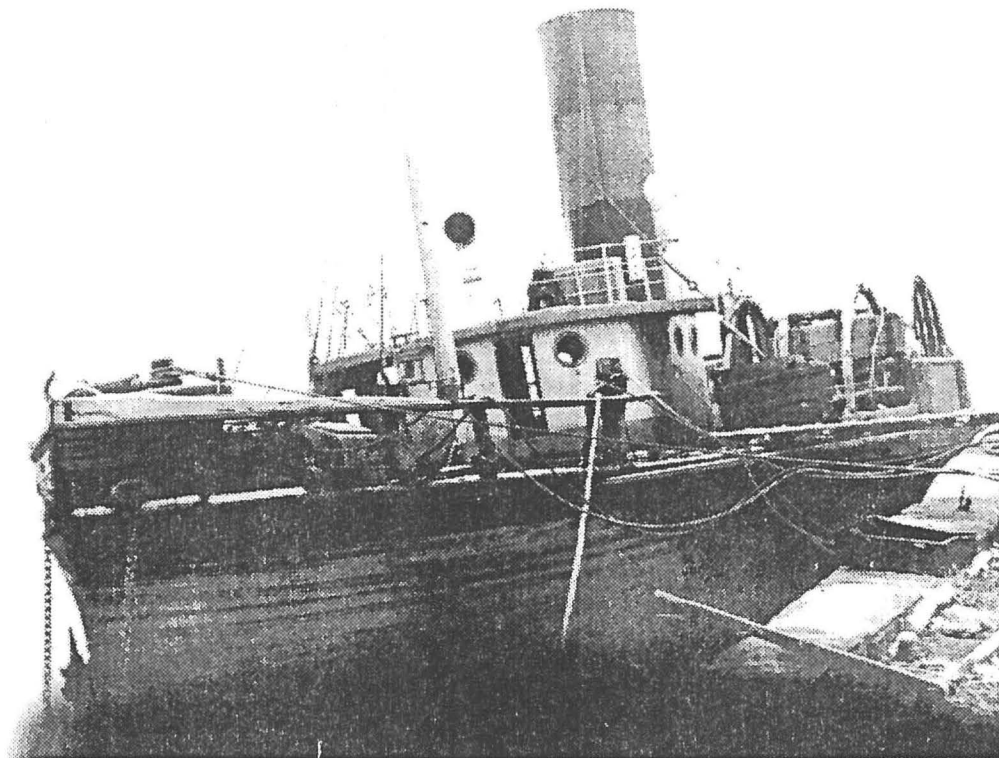
Photo: SFMNH 18.23723

Fig. 6. Sunk at the Clayton and Davy dock, 1969.

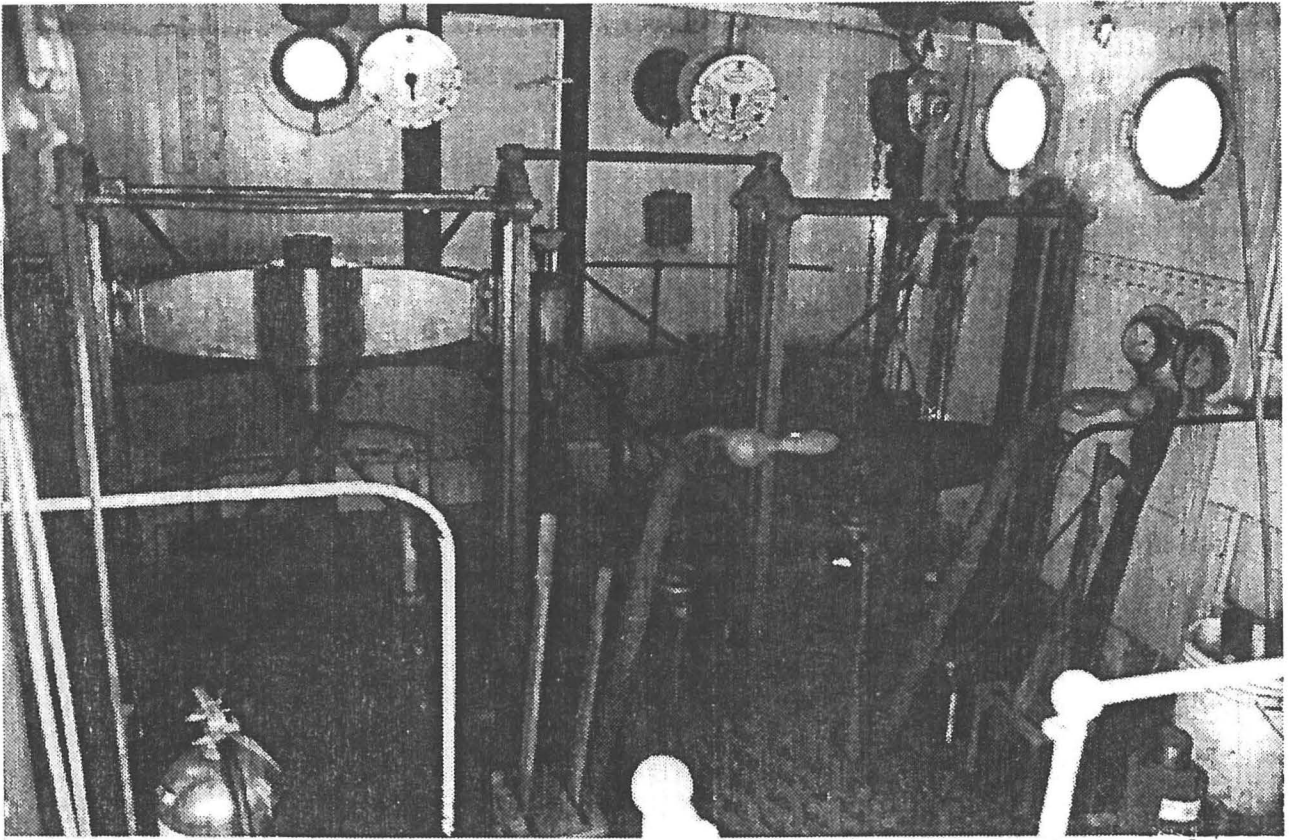
The vessel last steamed in 1979 and the machinery has not been properly laid up or regularly maintained since that time. As a result, the engines are frozen and exterior surfaces are rusting. The engines appear intact and complete, but true condition cannot be determined without disassembly and internal inspection.

Fig. 9. Top of engines as viewed from the upper engine room flat inside the fidley. The port piston rod (seen at left) is near the top of its stroke. The chainfall above the starboard piston rod is evidence of attempts to free the frozen cylinders.

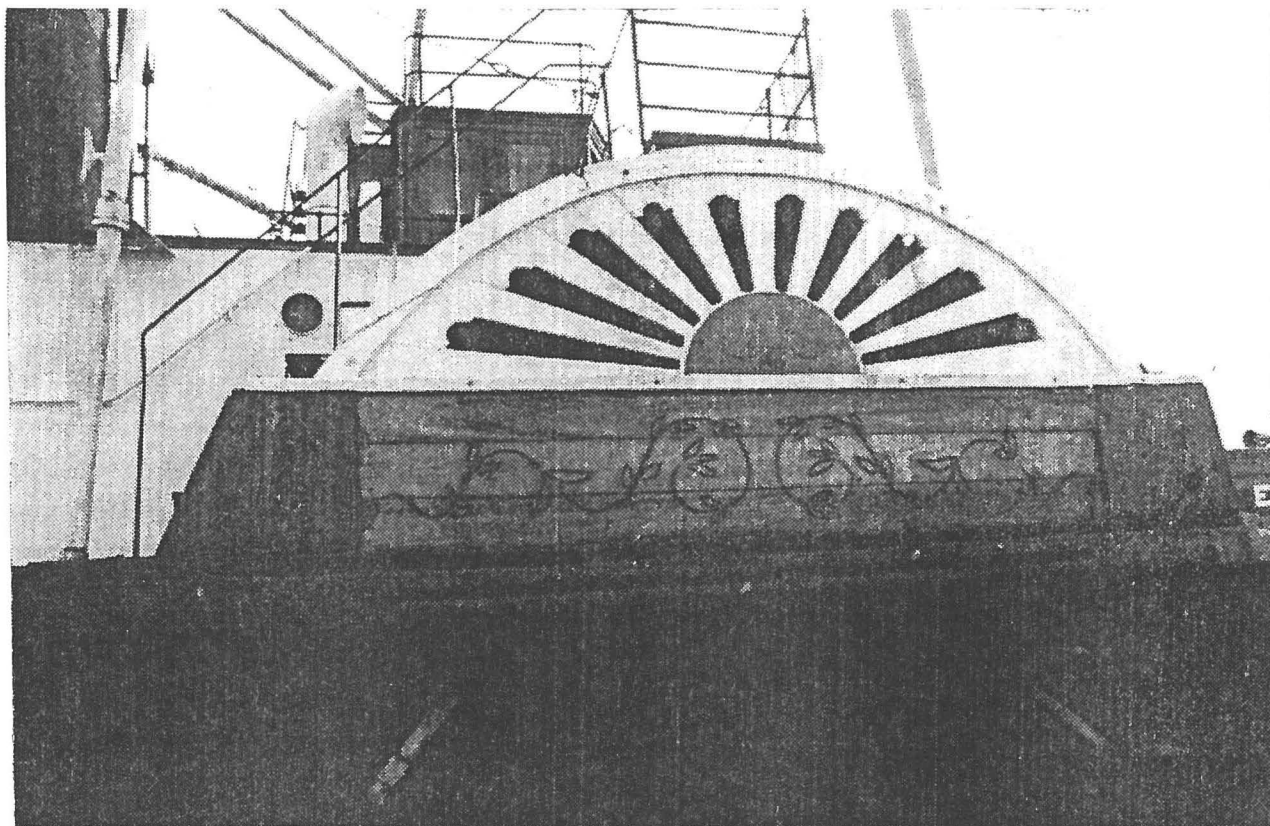
Paddle Boxes, Sponson Decks, Deck Houses, and Boat Decks: In terms of significance, these items can be considered as a unit. They have been extensively rebuilt and contain little historic fabric, but generally retain their original form.

Fig. 10. The starboard paddle box, completely rebuilt in 1969, is essentially as original, with exception of details such as the addition of the scrollwork carved in the outboard side.

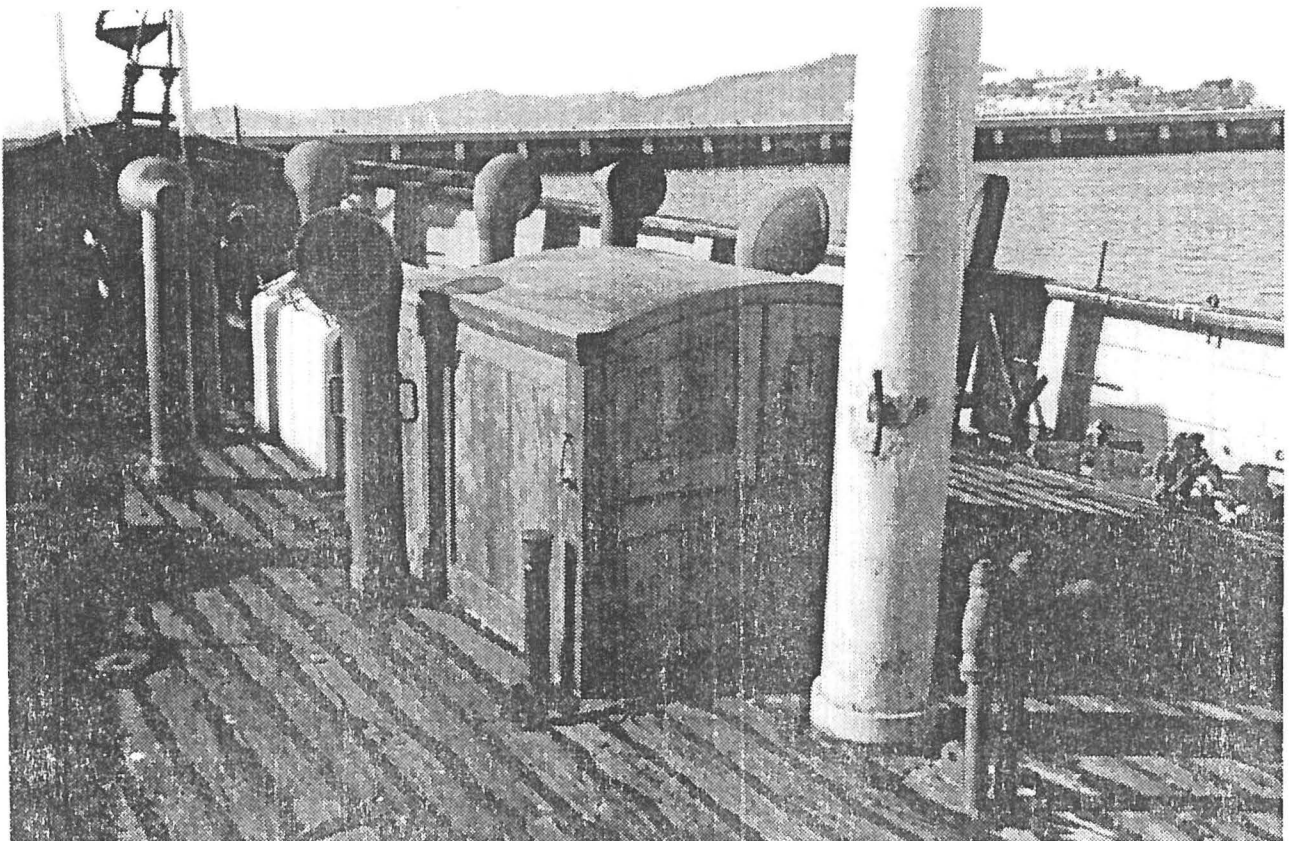
Ventilators: The numerous ventilators on the fore and aft deck (10 total) were added after the historic period. The vessel originally had only one ventilator on the fore deck and one or two aft. Although the existing ventilators are of a traditional type, their excessive numbers alter the appearance of the main deck.

Fig. 11. The numerous cowl ventilators on the foredeck look "salty", but are not an historic feature. The rebuilt scuttle forward of the mast is in the original location, but is oriented fore and aft, rather than thwartships, as the original was.

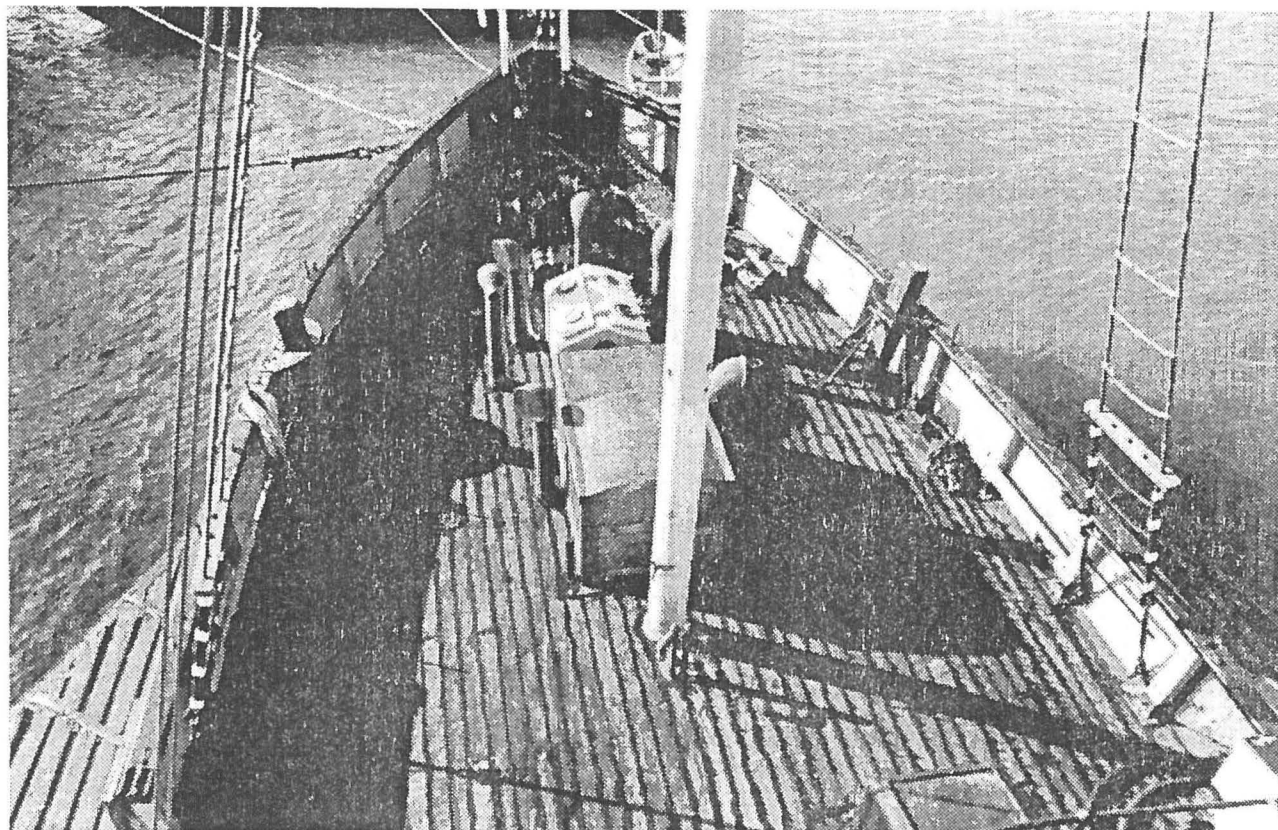
Fig. 16. EPPLETON HALL's foredeck, as seen from the bridge deck. Planking appears sound, but hides active corrosion on steel structure beneath.

The wood decks and many of the supporting steel deck beams were installed in 1969 and are not historic fabric. Unfortunately, the work done at that time was not adequate for long-term preservation. The steel deck structure has rusted beneath the wood planks and the expanding rust scale has lifted the planking, thus leading to further leakage and corrosion. Although the wood decking is not extensively rotten, all planking will have to be removed in order to preserve the steel deck beams and stringer plates beneath. Renewal of approximately 2,200 linear feet of deck planking will be required. To restore the decks to the original builder's specification, planking would be 5" x 2-1/2" yellow pine (Douglas fir could be substituted) and margin planks would be of teak. The amount of repairs, if any, the deck steel structure will need cannot be determined until the deck planks are removed. It is likely that the deck beams over the coal bunkers will have to be temporarily removed in order to scrap the nonhistoric fuel tanks.

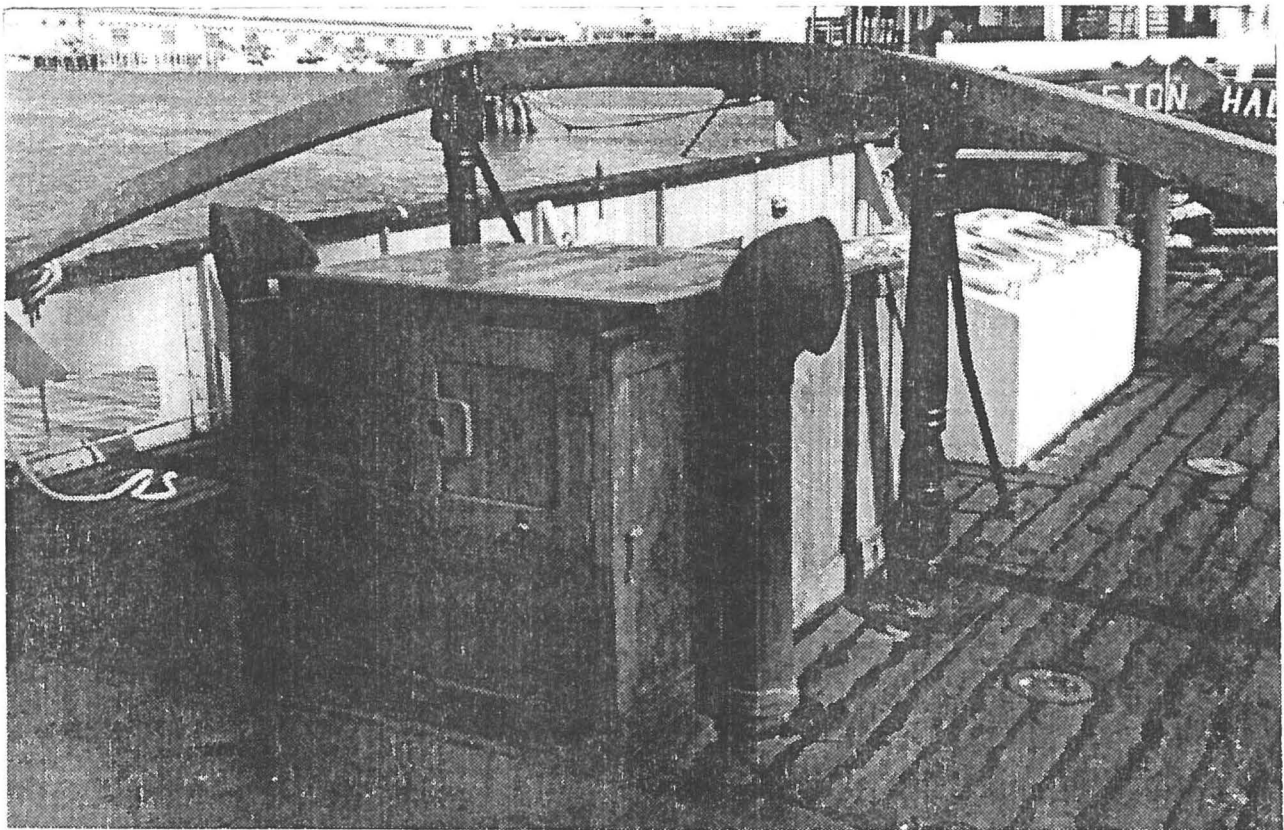
Fig. 17. The scuttle to the aft accommodations, with the aft skylight beyond. Arched structure above the scuttle is the forward towing bar.

The steel skylights should be sandblasted and coated, and broken lenses replaced (A tempting option would be to replicate the original skylights, particularly the aft one which appears to have been quite elegant).

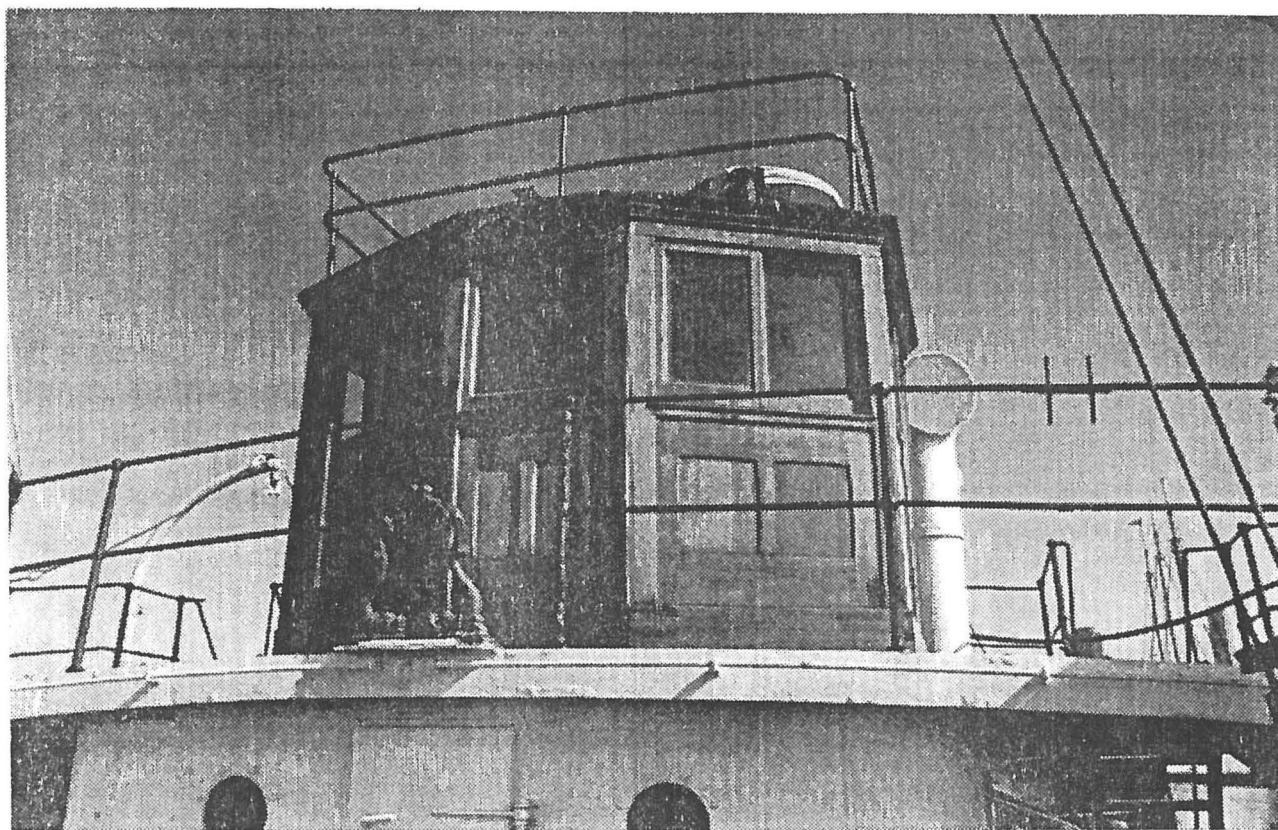
Fig. 18. EPPLETON HALL's teak pilothouse. Salvaged from a fishing trawler, it bears a resemblance to the original pilothouse.

To preserve the existing pilothouse, the rotten decking and beams on top will have to be renewed. The nonhistoric access ladder and railing on top should be removed to improve historic appearance. If further survey reveals that more extensive work is required to restore the existing pilothouse, it would be better to expend the effort on replicating the original one. Using the builder's plans and historic photographs, it should be possible to carry out an accurate replication.

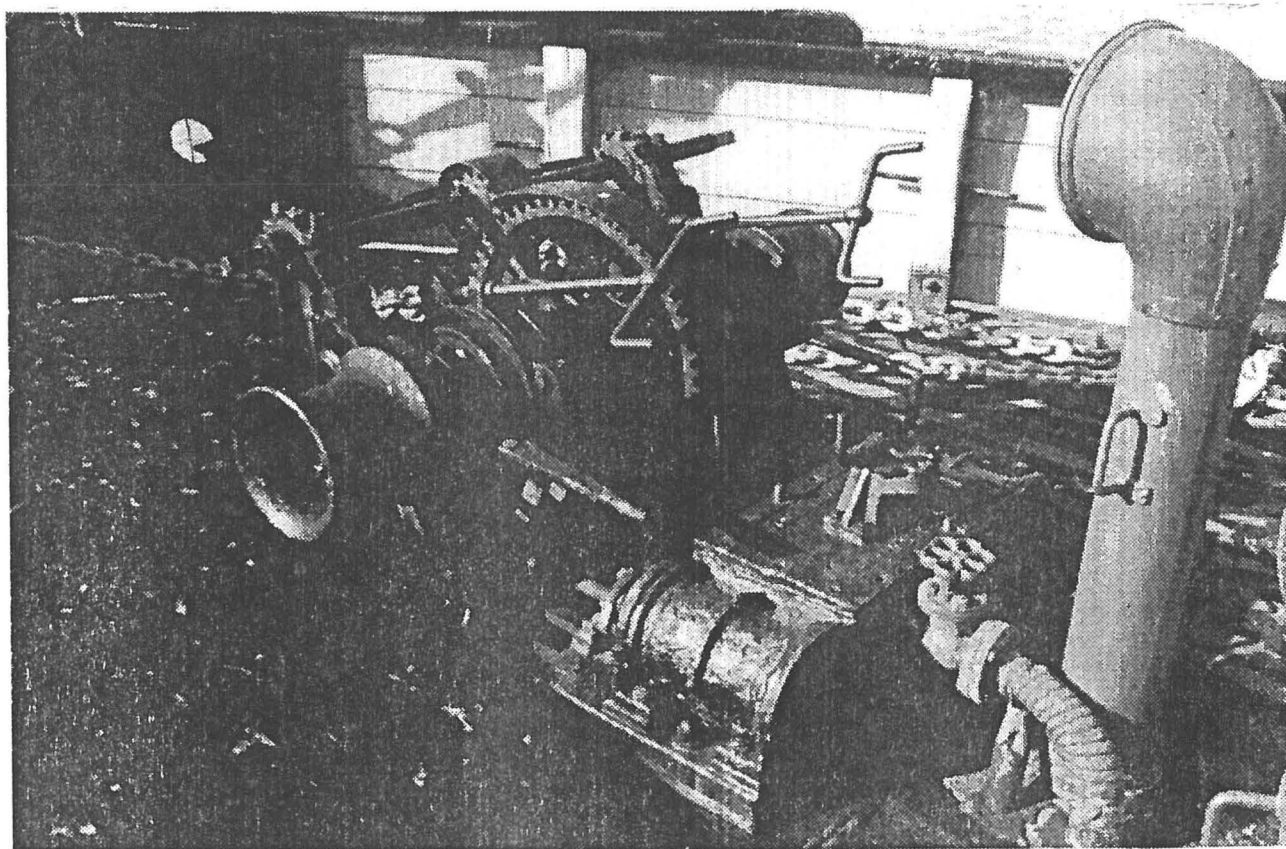
The anchor windlass is intact, but has been partially disassembled and is rusting away. The steering gear is also intact and shows similar signs of neglect.

Fig. 19. The steam-powered anchor windlass, an historic element.

The windlass should be removed to a shop where it can be disassembled for internal preservation. Some parts may need to be machined or fabricated, including the cylinder covers which appear to be missing. The exterior should be sandblasted and coated with a durable anti-corrosive coating. For additional protection, a weatherproof fabric cover could be placed over the

windlass when the vessel is not on display. Provision should be made for running the windlass on compressed air as a routine maintenance procedure.
